Maintenance Log

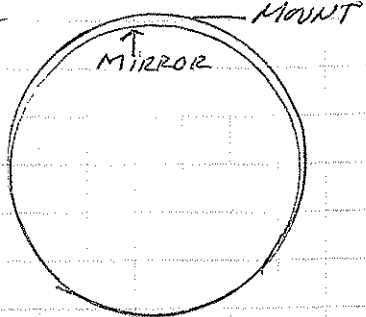
- Pressure dropped ~ 400 mbar before 3 hrs! Brought system down to 1,000 mbar, then put ~ 100 mbar He. removed end mirror as in directions. Mirror looked very dirty w/ powder like spotting. Needs to be cleaned. looked like this →
- O-ring also looked dried out needs replacement. Titled

- Also seemed that mirror was not seated "nicely" in mount, it looked like it was sagging down off center

- O-ring has the following specs: $\phi 32 \times 2$ Viton

* Note: When new o-rings arrive & the system is opened up again, double check that mylar ~~ring~~ ring is in place.

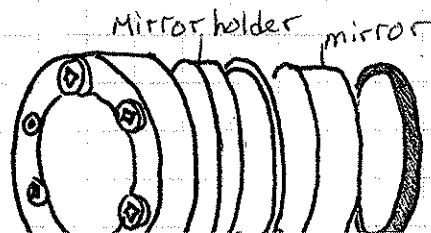
- Found a missing mylar ring, maybe I forgot it after the first install or maybe that was the problem the whole time. Charged system to > 2500 mbar @ 3:15 pm today
- This is how the window assembly goes

O-Ring dimensions are 32×2 mm

- Just remembered that there was a lot of corrosion on the o-ring groove. This could lead to improper sealing of the windows. Once the helium arrives I'll plan to clean out the gaffe w/ Q-Tips & Ethanol (low moisture) & replace the o-ring w/ the one that's been cleaned w/ rubber rejuvenator.

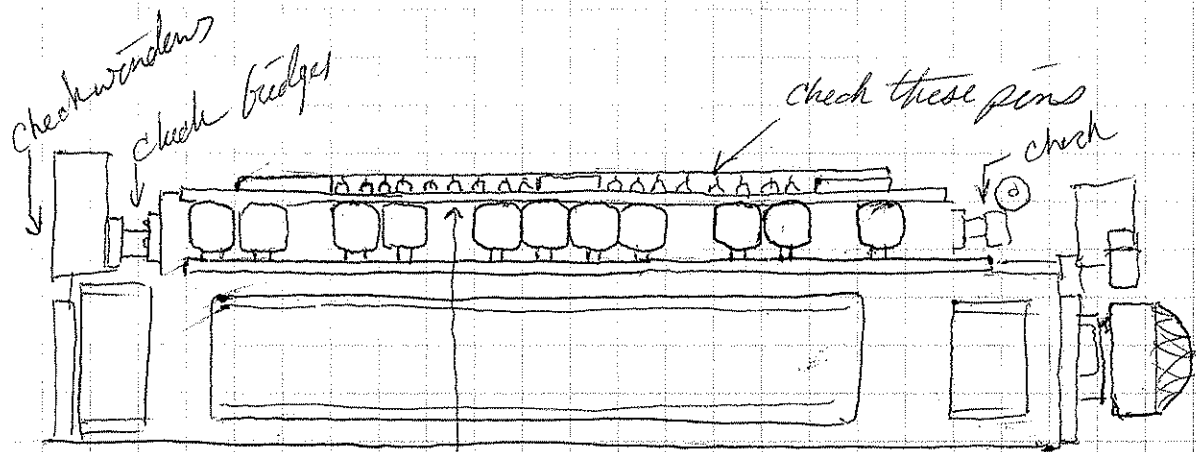
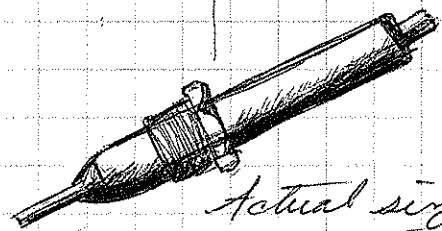
Actual size drawing of one of the pins

• Today we (Dr. Hines & I) are supposed to leak check in the following places.

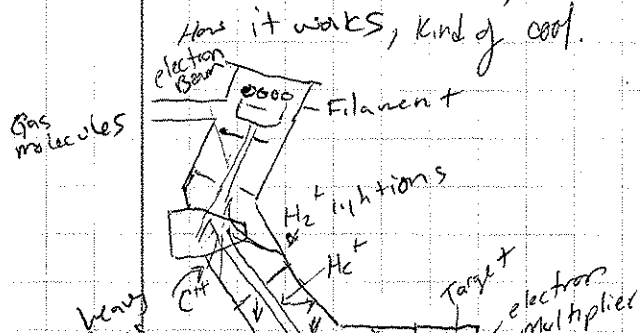
Leak Rates

- Rear window mount ≈ 1 cc/sec $\times 10^{-8}$ Scale
- Front window mount ≈ 1.5 cc/sec $\times 10^{-8}$
- $\approx 10 \times$ rear window $> 1 \times 10^{-8}$

Top - 6th From Rear - major leak.

- 1) Get New o-rings, re-seal
